DOT/FAA/AR-99/4,II

Longitudinal Acceleration Test of Overhead Luggage Bins and Auxiliary Fuel Tank in a Transport Airplane Airframe Section, Part II

October 2000

Final Report

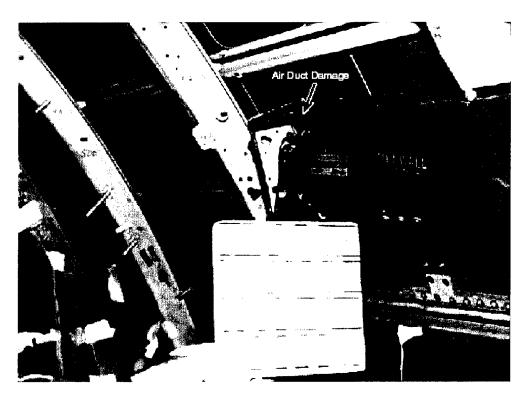
The center of the three support brackets, AL76, was bolted to the air duct and also was attached to the fuselage frame through a link/turnbuckle assembly. The link/turnbuckle assembly was bolted to a flange that bolted to the fuselage frame. After the test, the support bracket remained attached to the bin; however, the support bracket completely separated from the air duct and the flange separated from the fuselage frame. The damage to the air duct can be seen in figure 17. The support bracket is shown in figure 18 and the separated flange and link/turnbuckle assembly can be seen in figure 19.

FIGURE 17. SUPPORT BRACKET AL76 AIR DUCT DAMAGE
